(SIXTH QUARTERLY REPORT)  
PRESSURE MEASURING SYSTEMS FOR  
CLOSED CYCLE LIQUID METAL FACILITIES

Consolidated Controls Corporation  
Bethel, Connecticut

SIXTH QUARTERLY REPORT  
June 1, 1965-August 31, 1965

14205  
Continuing development of a thermionic diode pressure transducer for liquid metal applications is described. Two test models were fabricated and installed in the Vacuum Test Facility. One of the models incorporated the C-129Y double convolution pressure capsule previously tested using the optical technique. A cross-sectional cut was made of the representative Nb-1Zr/Lucalox seal which recently underwent life testing. Analysis of the cross-section indicates that seals fabricated by this technique will meet the performance requirements for temperature and internal pressurization. The 500 hour potassium compatibility test was completed. After the test, the four test pressure capsules were found to be still leak tight. Metallographic examination showed no evidence of potassium attack in the capsule interior. Initial work on the transducer signal conditioning equipment established the various functional blocks of the system. The differential pressure transducer effort was

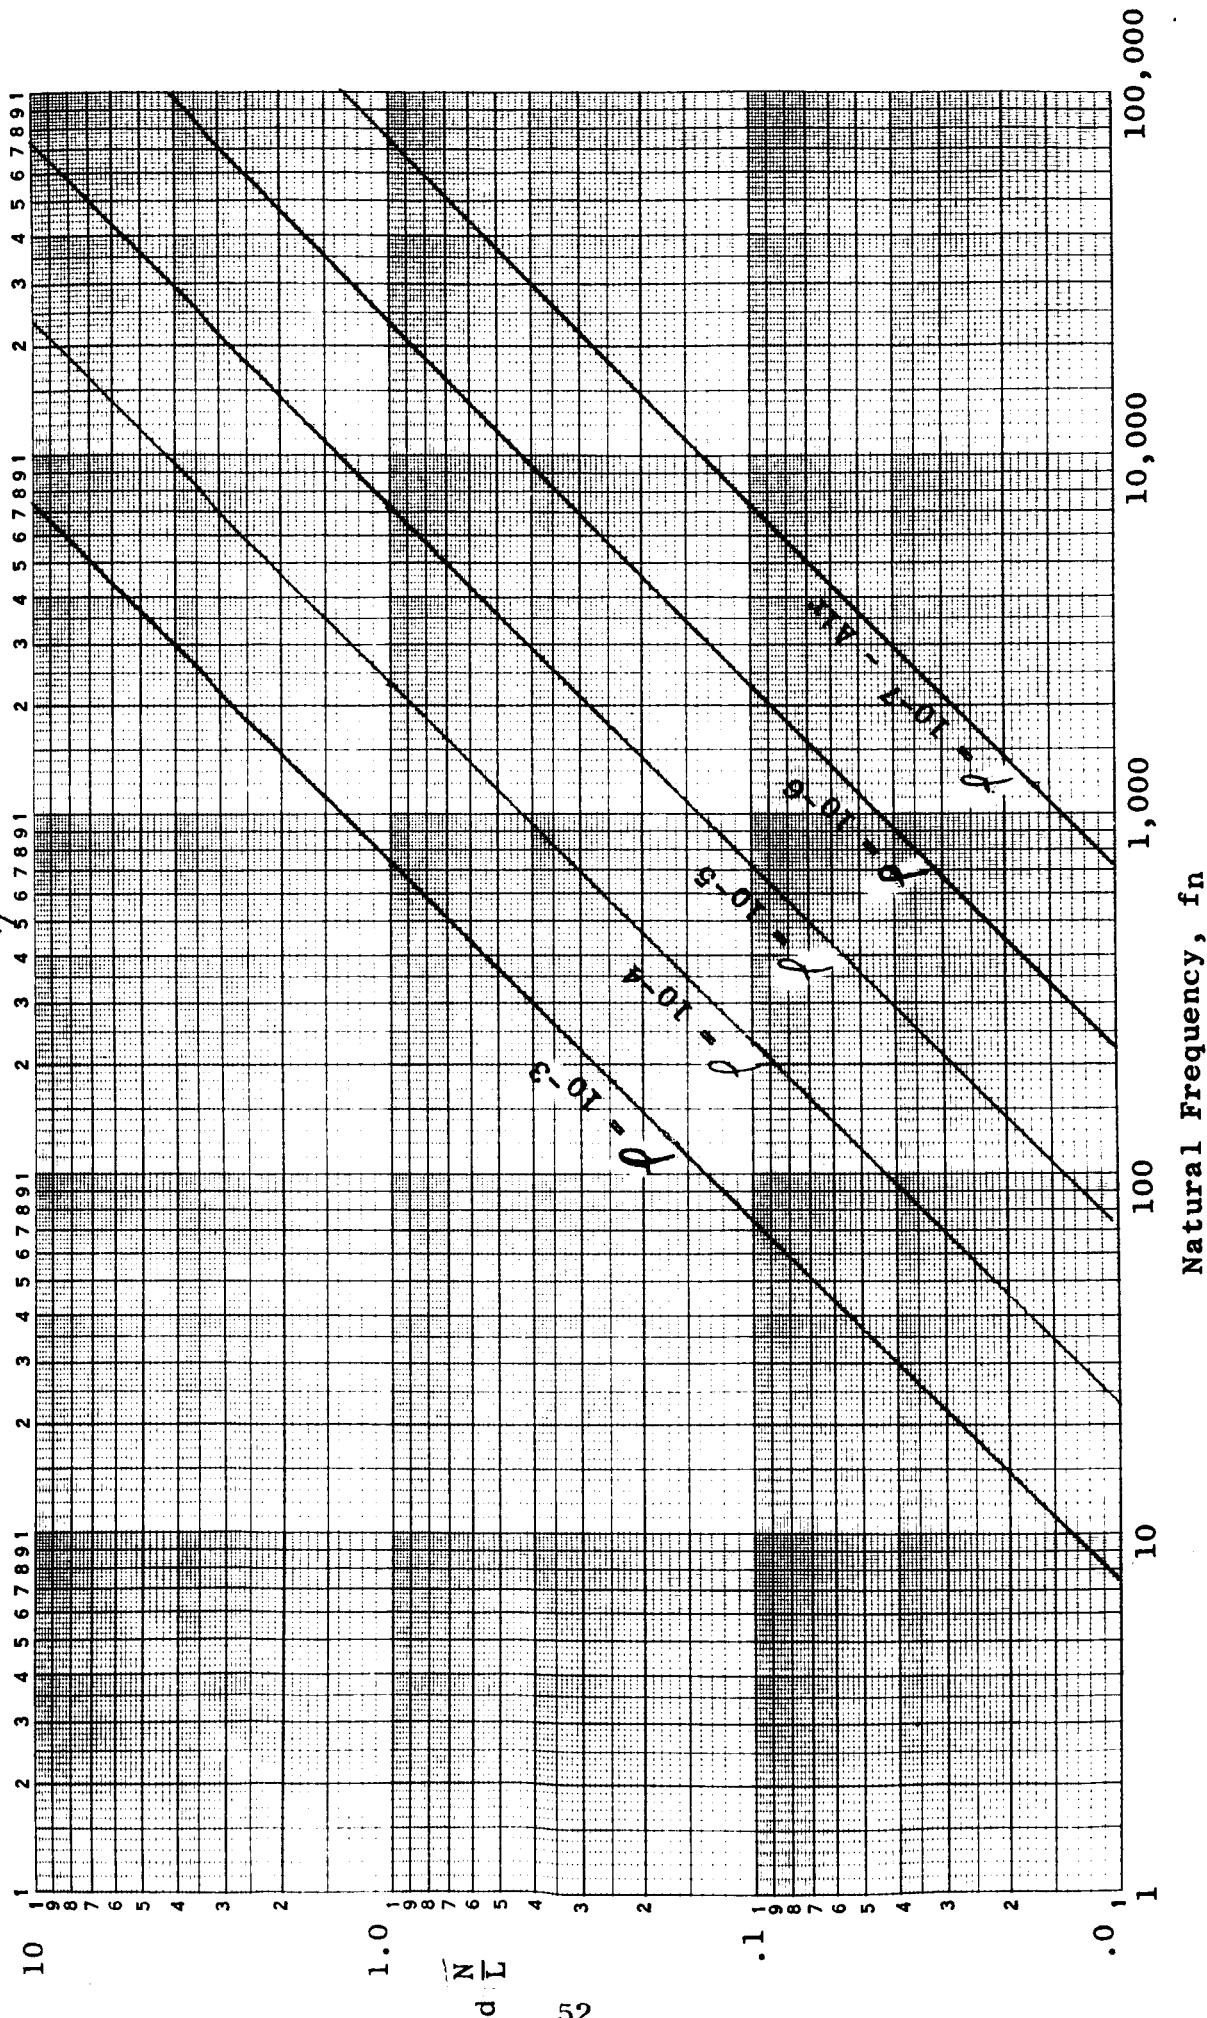
$$f_n = (23) \left( d \sqrt{\frac{N}{L}} \right) \left( \frac{1}{\sqrt{\rho}} \right)$$

FIGURE 2  
Transducer Natural Frequency Characteristics

From equations A24 and A26 it will be noted that the various terms which are used to calculate the natural frequency and the damping coefficient have been grouped according to their availability. For the natural frequency calculation the first term is  $\sqrt{\frac{3\Delta P/\Delta V}{64\pi}}$  which includes the values associated with the transducer. Once this term is calculated for a particular transducer, it need not be changed for any application problem. The second group is representative of the fluid  $\left(\frac{1}{\rho}\right)$  to be measured and is also fixed for a given application. The last

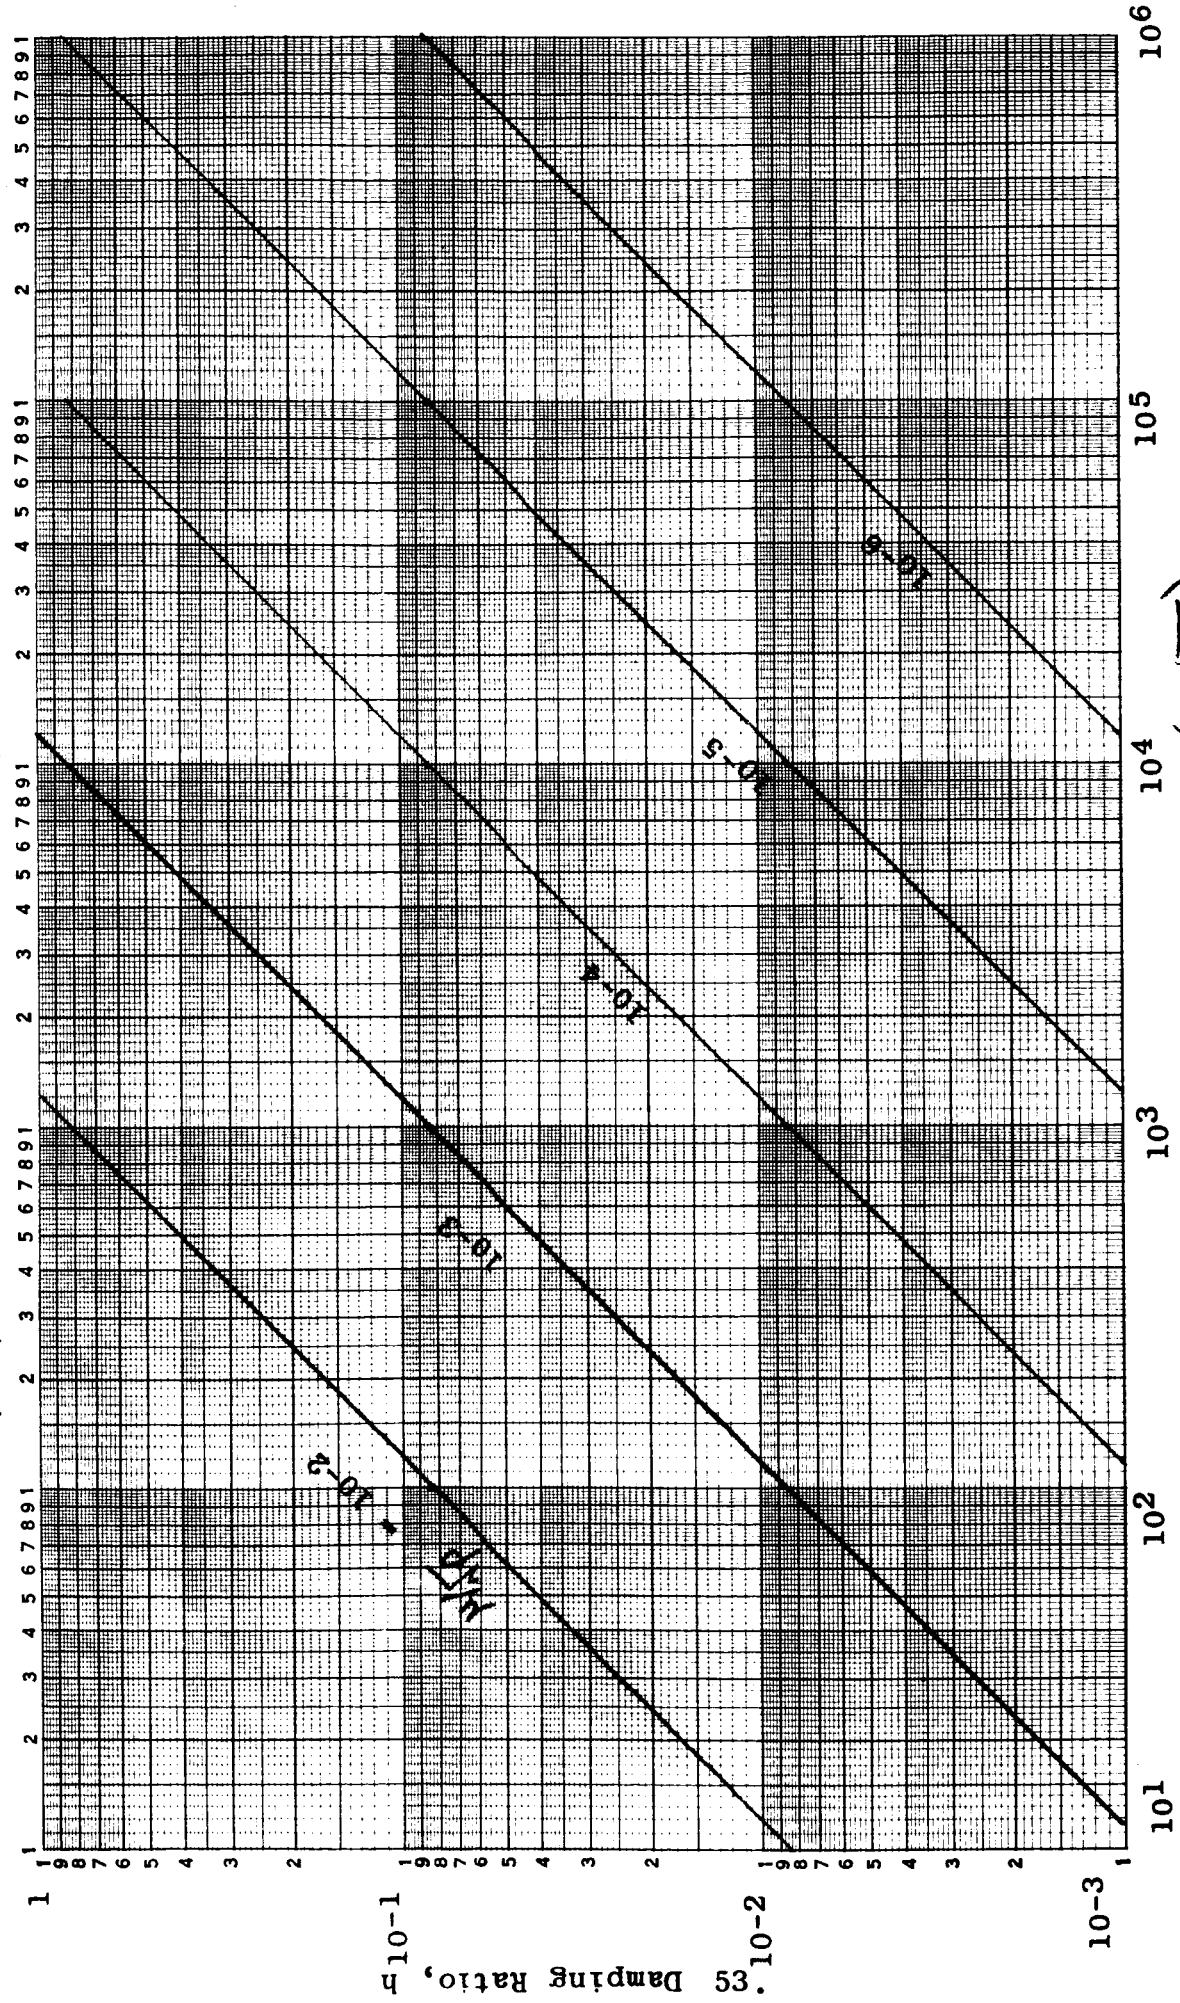
$$h = \left( 16 \sqrt{\frac{3}{\pi \Delta P}} \right) \left( \frac{\mu}{\sqrt{\rho}} \right) \left( \frac{1}{d^3} \sqrt{\frac{L}{N}} \right) = (83.4 \times 10^{-3}) \left( \frac{\mu}{\sqrt{\rho}} \right) \left( \frac{1}{d^3} \sqrt{\frac{L}{N}} \right)$$

FIGURE 3  
Transducer Damping Characteristics

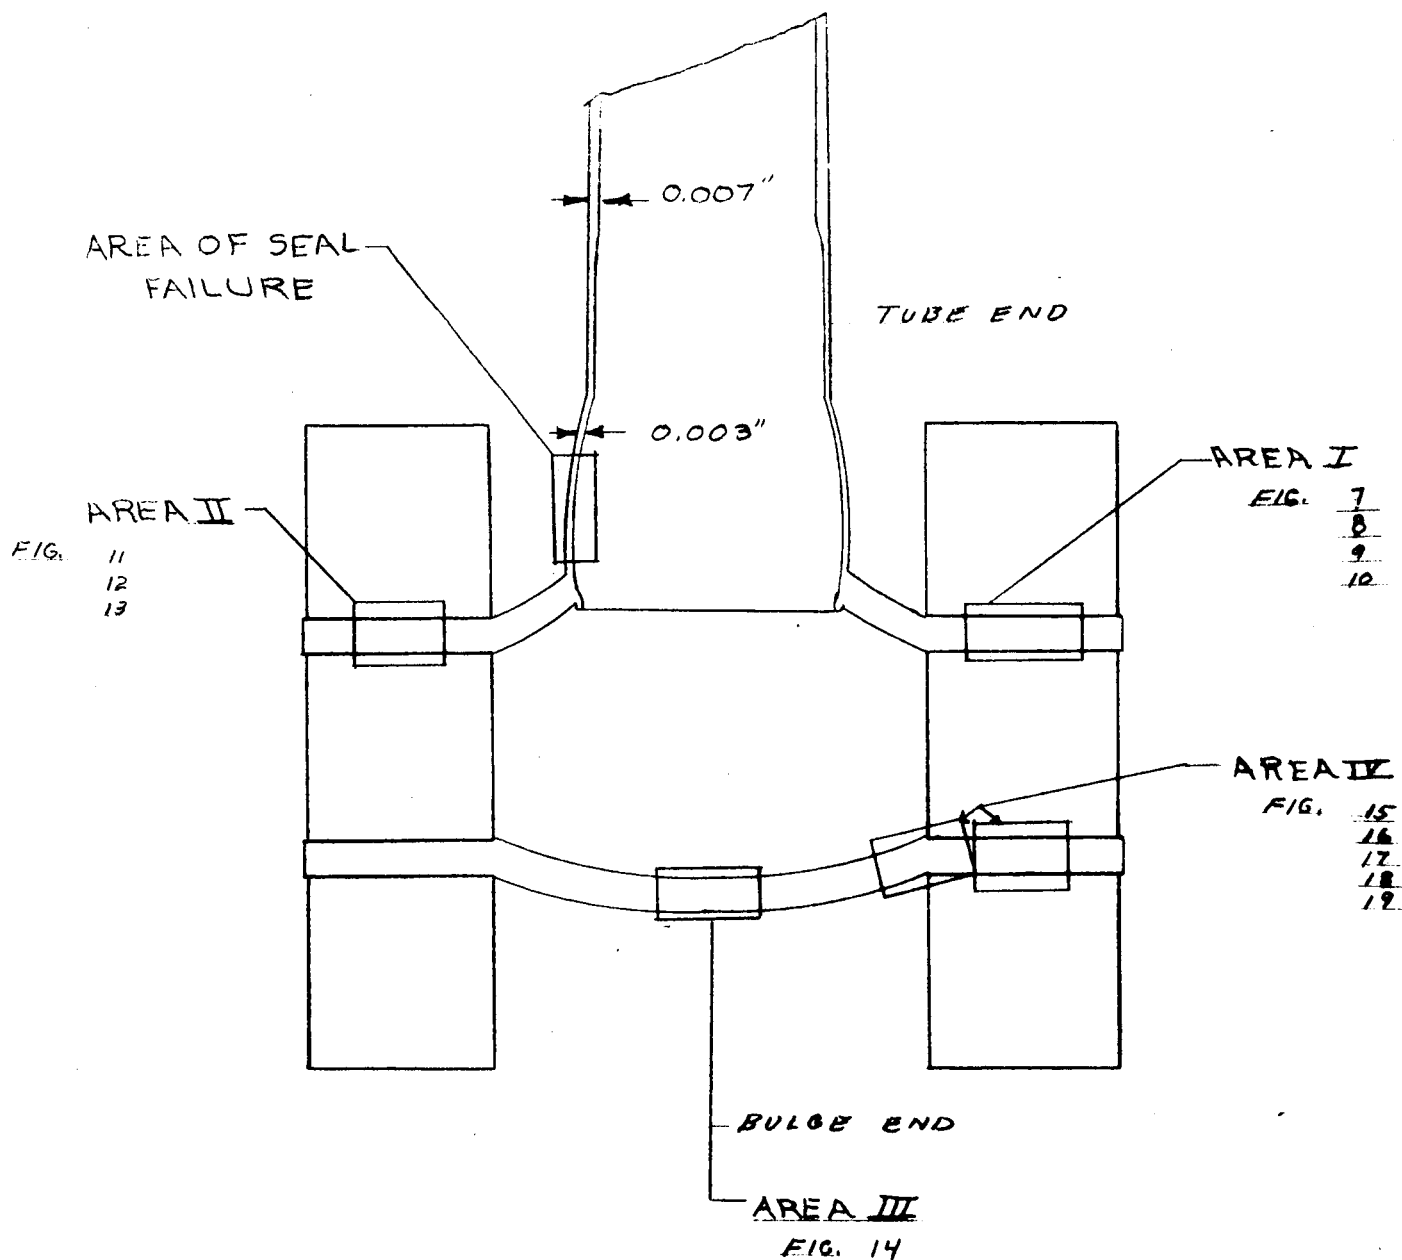
FIGURE 6  
REPRESENTATIVE Nb-1Zr/LUCALOX SEAL

The metal-ceramic joining technique proposed for use in the transducer was tested to failure as described in the Fifth Quarterly Report (Reference 1). The test sample contained seals between Lucalox and Nb-1Zr. The Lucalox was metallized with a tungsten/yttria compound and brazed with a nickel/niobium/titanium alloy. A sketch of the test seal section after test is shown in Figure 6.

As seen in Figure 6 the failure occurred in the distended pressurizing tube which had been re-crystallized by the heliarc welding. The seal was removed from the test fixture and microscopically examined. The location of the leak was determined by helium leak check and then pin-pointed by internal pressure and soap bubble technique.

had taken place. The center of the lower end plate had been displaced 0.010 inch. The upper end plate with welded tube had been displaced 0.022 inch. The pressure tube had distended in the recrystallized area from 0.090 inch OD to 0.107 inch OD. Its wall thickness was thinned in the area of failure from 0.007 to 0.003 inch.

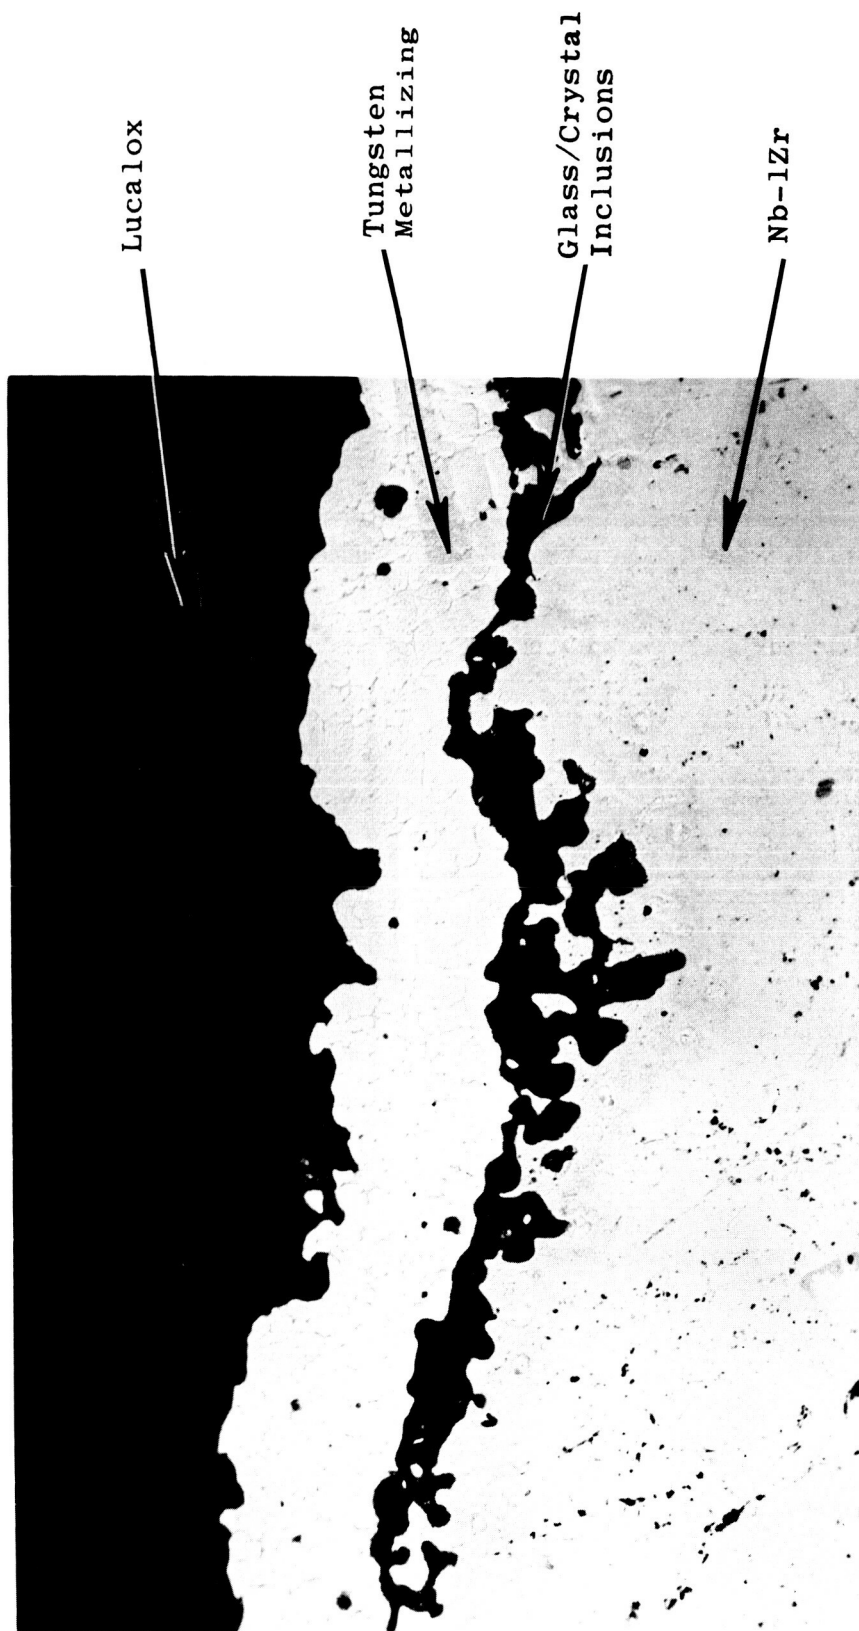
FIGURE 9

Tube end interface showing glass, etched, 500X, Area I

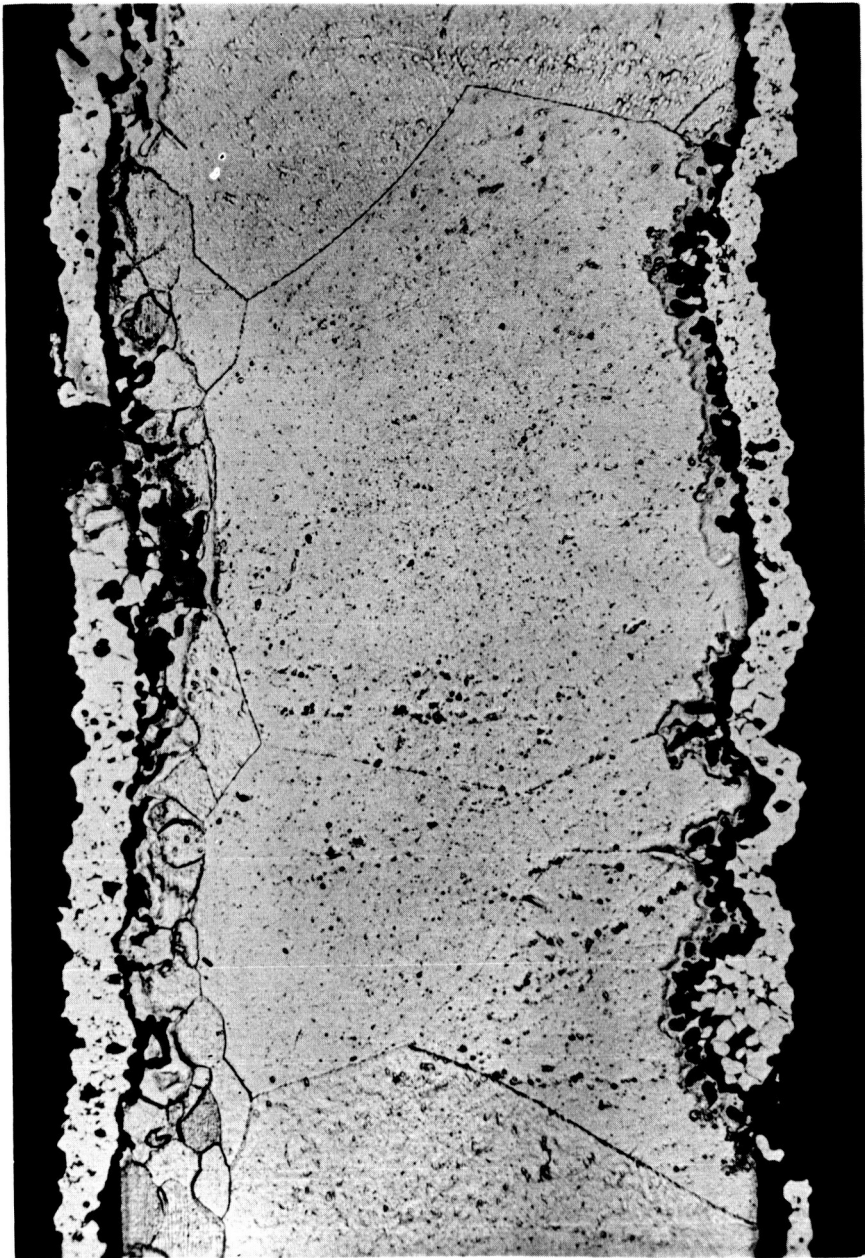
FIGURE 12

Tube end metal member showing large grain size, etched, 200X, Area II

By comparing the relative grain sizes of the Nb-1Zr tube plate (Figures 10 and 12) and blank end plate (Figure 14) it is seen that there is a marked disparity between the two pieces. The grain size in the blank end plate (Figure 14) is non-uniform but falls in the range 0.001 to 0.008 inch diameter. On the other hand, in the tube plate (Figures 10 and 12) the grains are so enlarged that the 0.018 inch thick Nb-1Zr sheet is essentially one grain thick. However, there are a few much smaller grains on one surface of the metal. The enlarged grain growth is considered to have occurred during the heliarc welding of the tube to the tube plate. The layer of small grains is due to the presence of surface contamination,

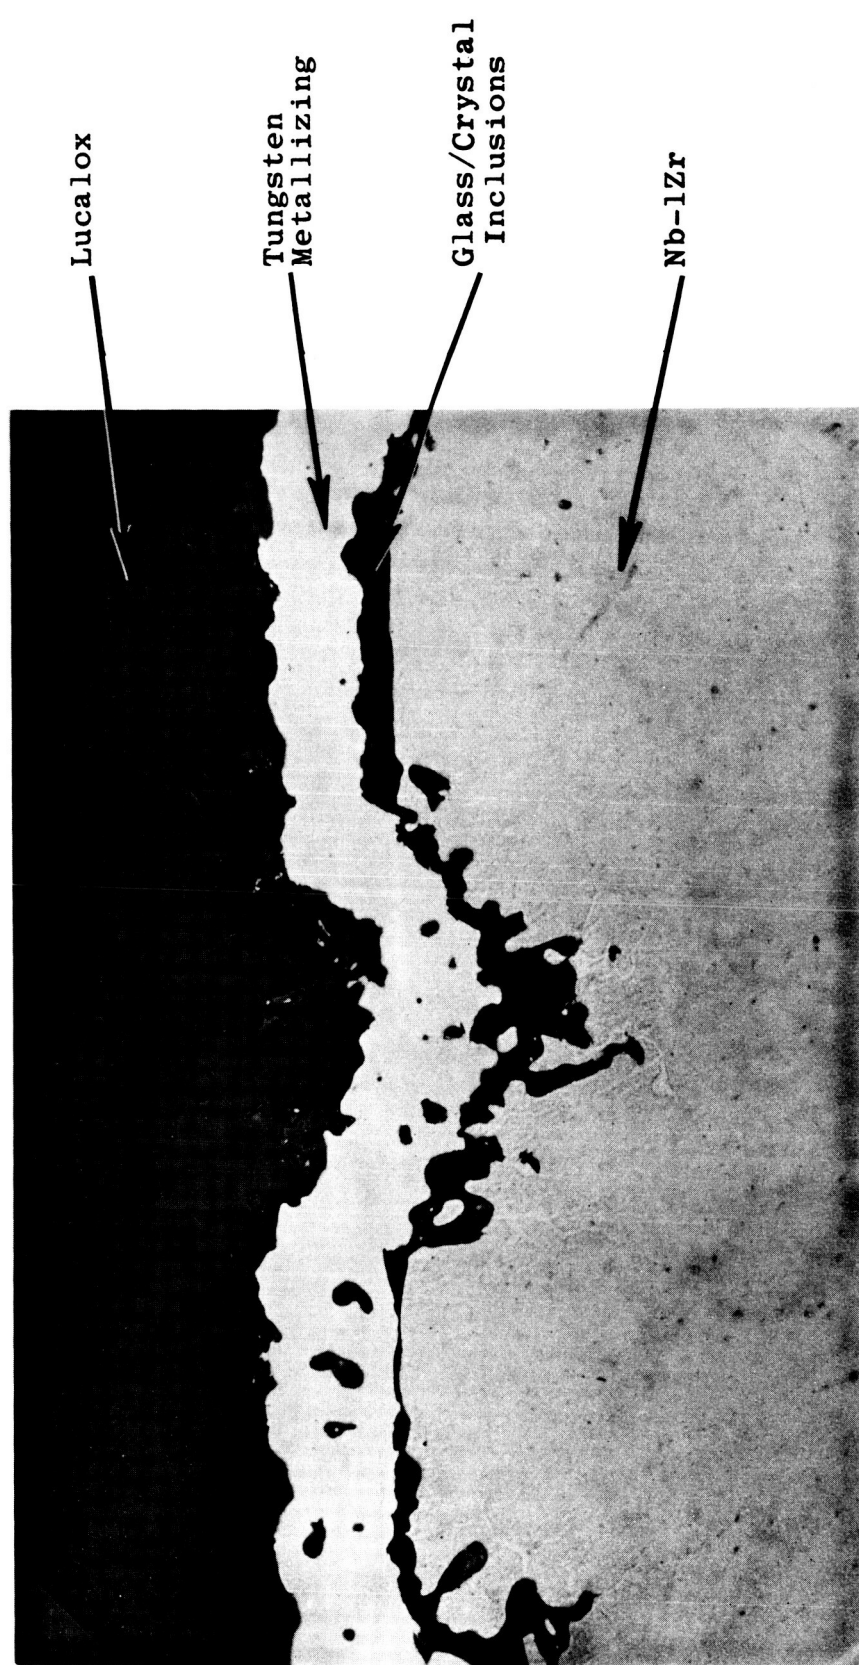
FIGURE 13

Tube end interface showing crystal-glass, oxygen attack, etched, 500X,  
Area II

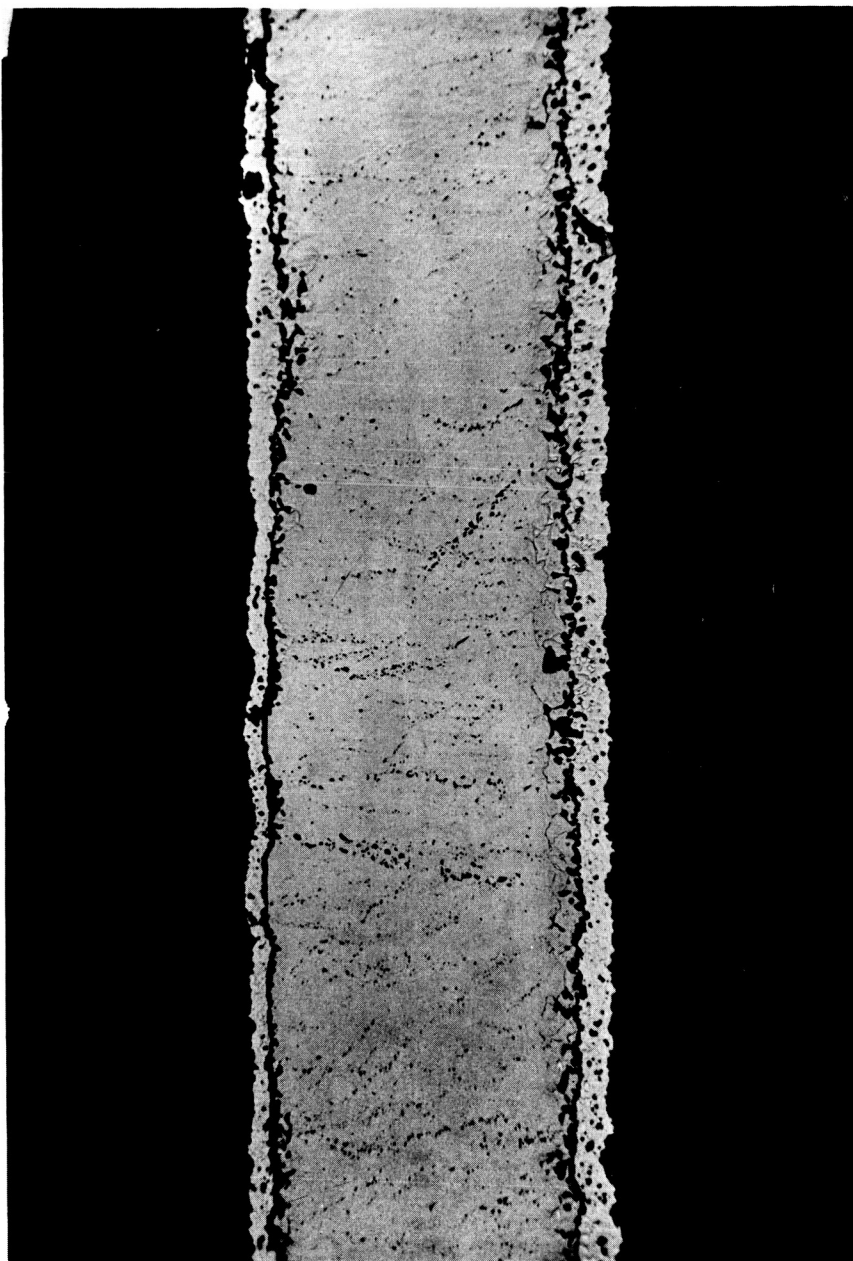
FIGURE 15

Ceramic to metal seal, bulged end, unetched, 100X, Area IV, site of Figures 17 and 18. Section across which X-ray probe is taken.

Figures 15 and 19 show photomicrographs of Area IV as indicated in Figure 6.

Figures 17 and 19 show portions of Figure 15 at 200 X and 500 X magnification, respectively. Figure 19 was printed by "dodging" or shading the negative during printing so as to reveal the structure of the Lucalox as well as that of the metal. This particular section was selected for the X-ray microprobe traverse described in a later section of this report.

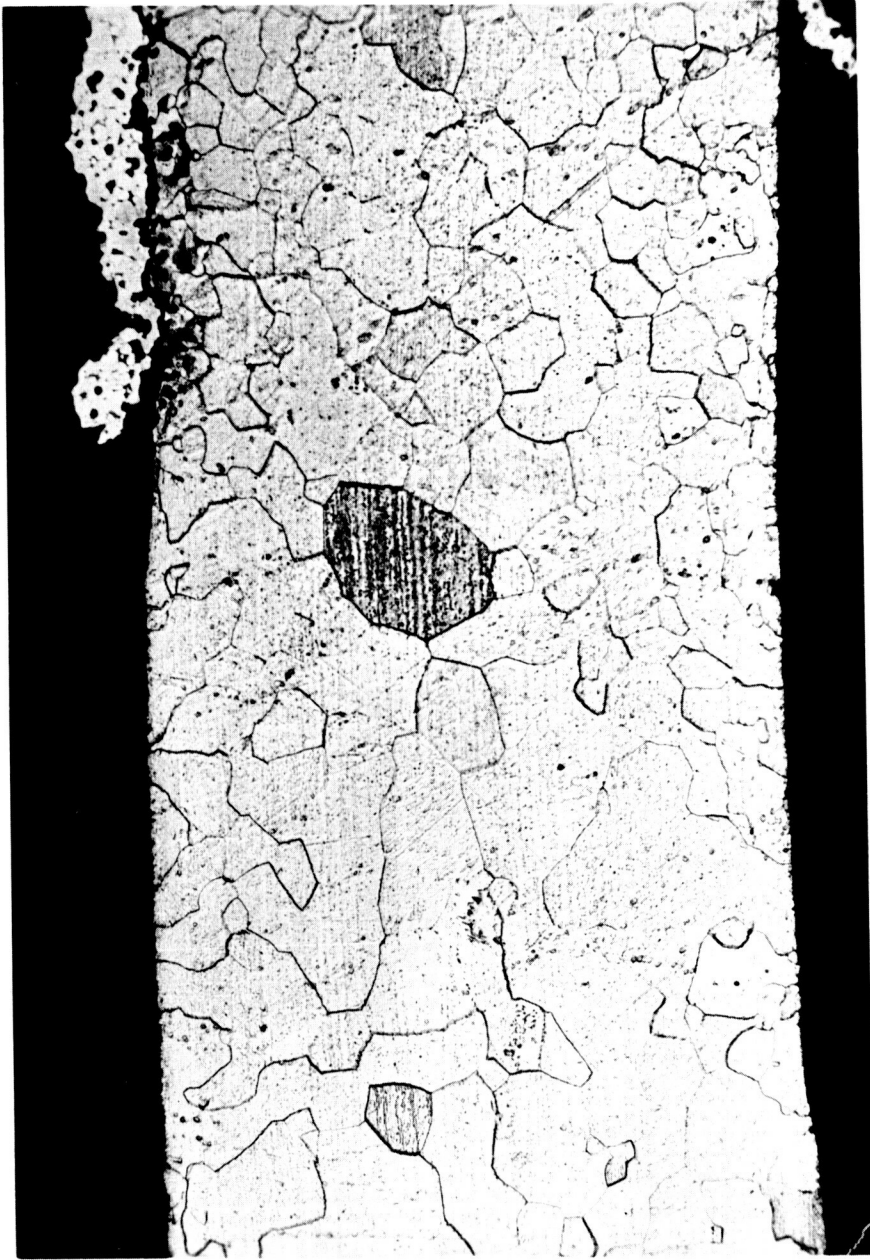
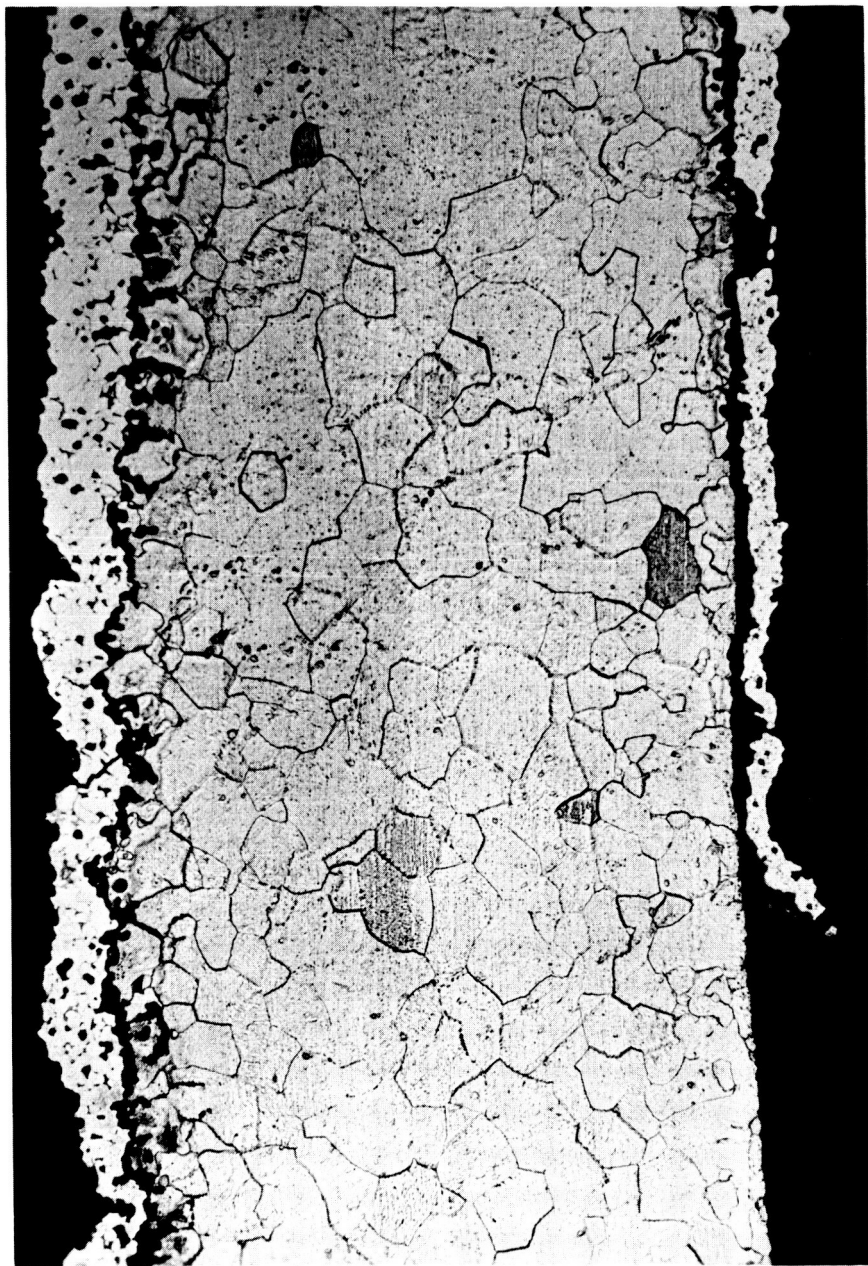
Bulged end metal member at braze meniscus area, etched, 200X, Area IV

In all the sections of this seal examined, no evidence was observed of cracking, separation, peeling or exfoliation of any of the layers comprising the seal. Most noteworthy are the sections illustrated in Figures 16 and 17 which show the border of the metallizing at the inner face of the Lucalox rings. The metallizing at these borders was subjected to the most severe stress, so much so that the Nb-1Zr blank end disc bulged under the test pressure without causing the metallizing to peel or crack.

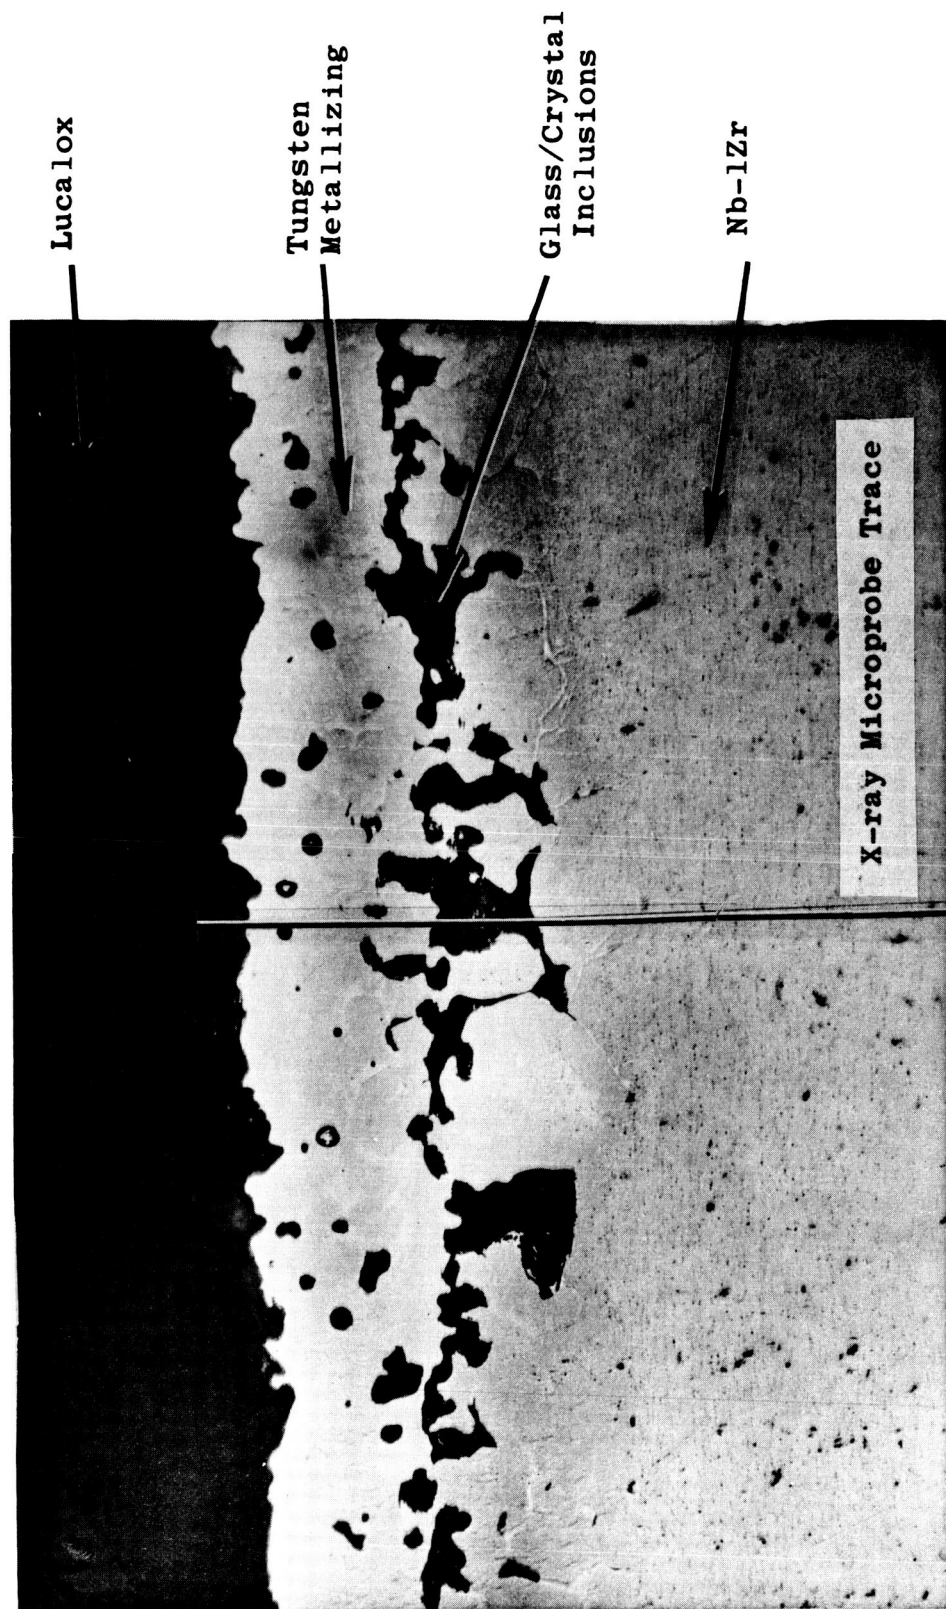
FIGURE 19

Bulged end interface showing crystal-glass, oxygen attack, etched, 500X, Area IV. Shows X-ray microprobe trace line.

An X-ray microprobe analysis was performed on a section selected to give optimum analysis of the phases observed in the photomicrographs. The trace traverse corresponds to the vertical line shown on Figure 19 running from Lucalox to Nb-1Zr. The traces given in Figures 20 to 22 have been displayed so that the right hand side of the trace corresponds to the top of the line indicated in Figure 19.

The traces show the major elements present are W, Nb, and Ni. There is a remarkable similarity in the shapes of the W, Nb, and Ni traces which suggest an alloy of essentially uniform composition, i.e., a solid solution. Two sharp Al and Y peaks are present which presumably could represent the two rounded particles of glass observed in the photomicrograph of the tungsten layer (see Figure 19). Ti is present in small quantities.

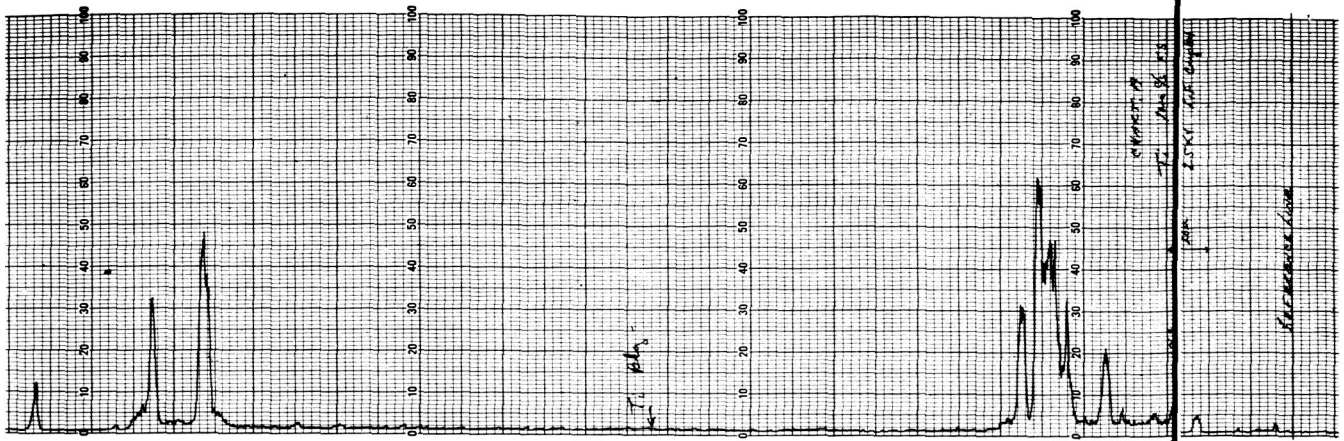
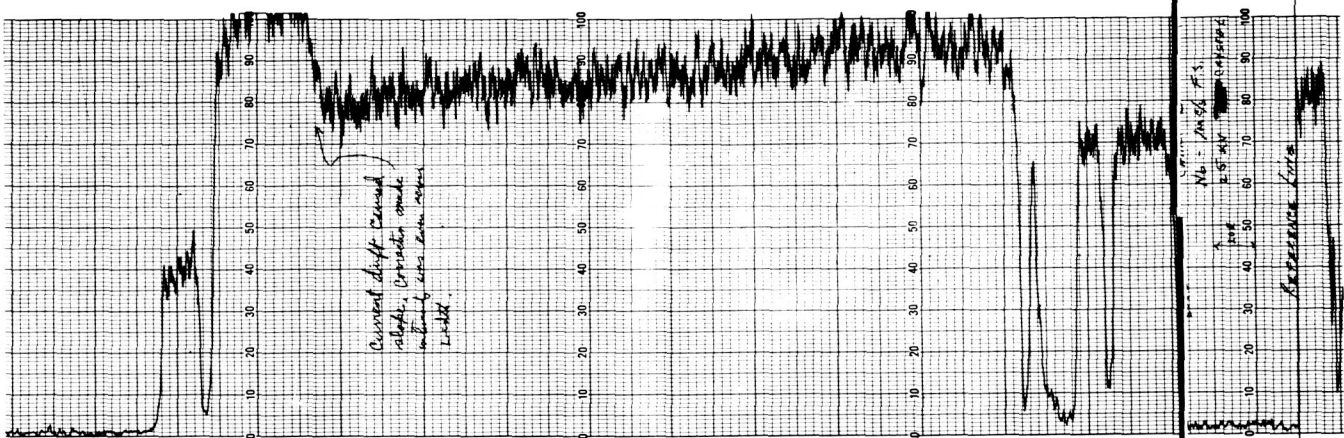
Figure 20. X-ray Microprobe Traces of Metal-Ceramic Seal.  
 Lucalox Metallized with Tungsten-yttria, and Brazed to Nb-1Zr  
 with Ni/Nb/Ti Alloy.  
 Traces Recorded with LiF Crystal, 25KV Accelerating Potential.

In some places where the material is known to be of essentially constant composition, e.g., in the center of the Nb-1Zr member, some peaks and valleys are observed. These are not peaks representing a change in composition, but are topographic features caused by discontinuities in the surface such as pits, grain boundaries, etc.

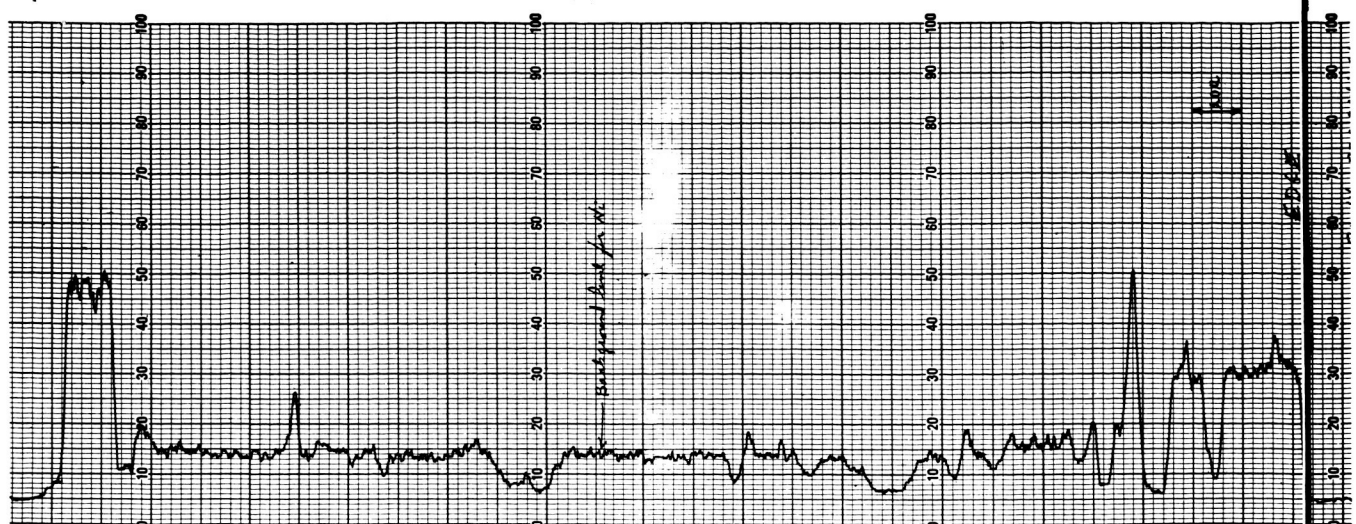
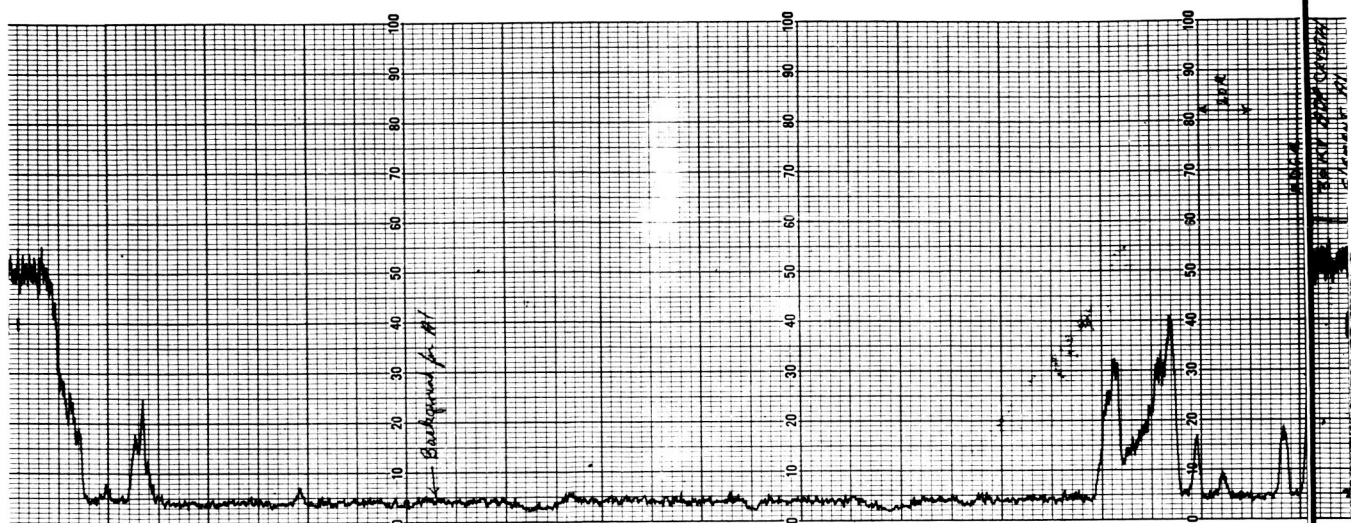
Figure 21. X-ray Microprobe Traces of Metal-Ceramic Seal.  
 Lucalox Metallized with Tungsten-yttria, and Brazed to Nb-1Zr  
 with Ni/Nb/Ti Alloy.  
 Traces Recorded with ADP crystal, 30 KV accelerating potential.

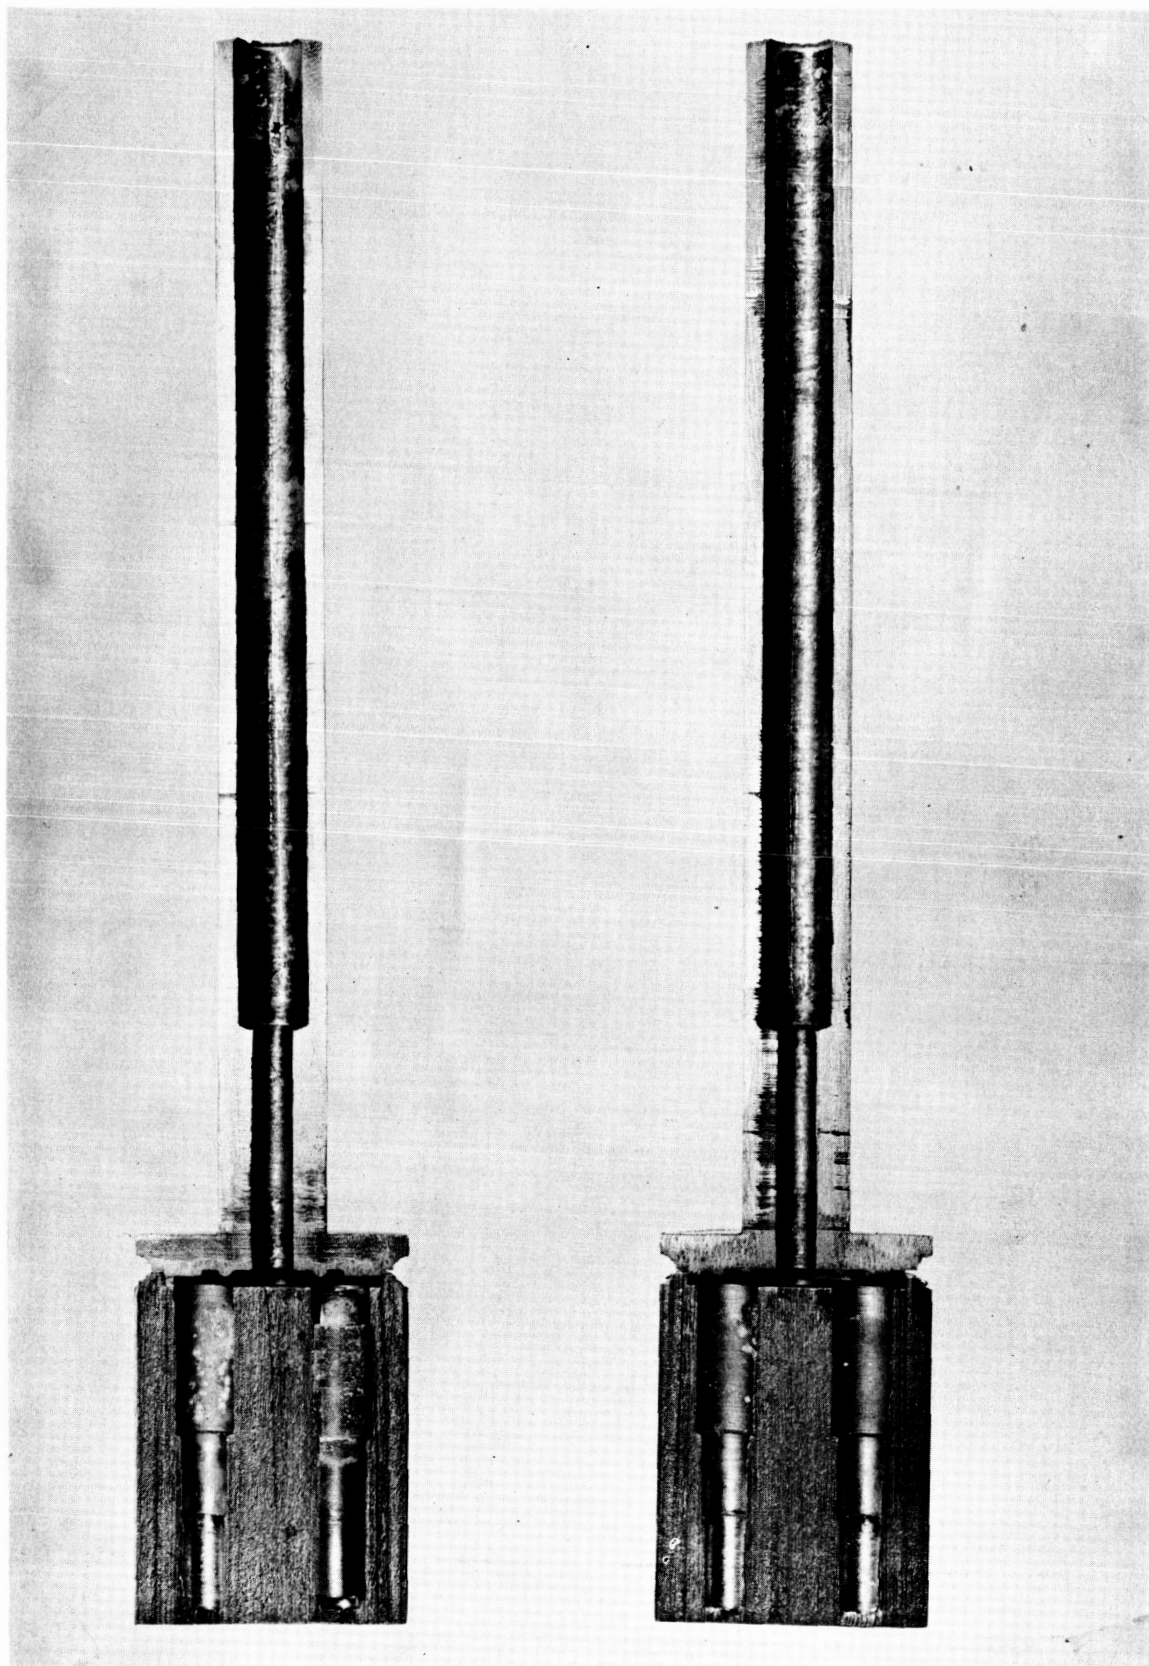
FIGURE 23

Terminal compatibility capsule in "as sectioned" condition after test with one terminal in place. (Full Scale)

Figures 23 to 27 show photographs of the five test capsules in the "as sectioned" condition. Figure 23 shows the terminal capsule with one terminal in

position, the other three terminals having been removed. It is seen that while the lower part of each terminal cavity is bright and clean, the housing shows traces of a white corrosion product where the Lucalox portion of the terminal was in contact with the housing. The upper tube shows a black corrosion product along its length.
